# City of Colleyville

# City of Colleyville Historical Preservation Committee Agenda Briefing

Discussion of the future use of Bidault House and Webb House

# **Bidault House & Webb House Property Assessment**

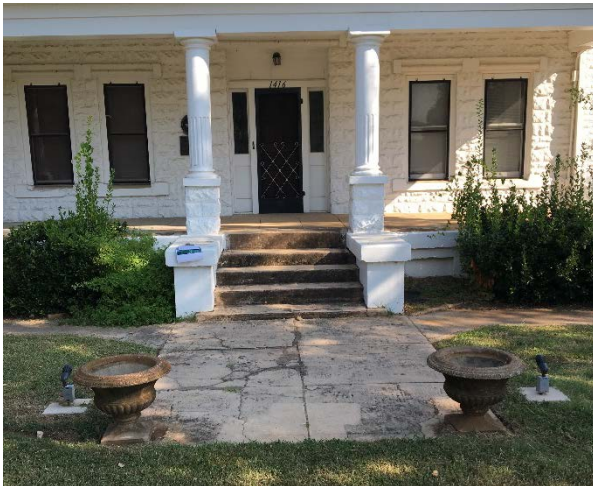
*The existing first floor is raised above the existing grade*

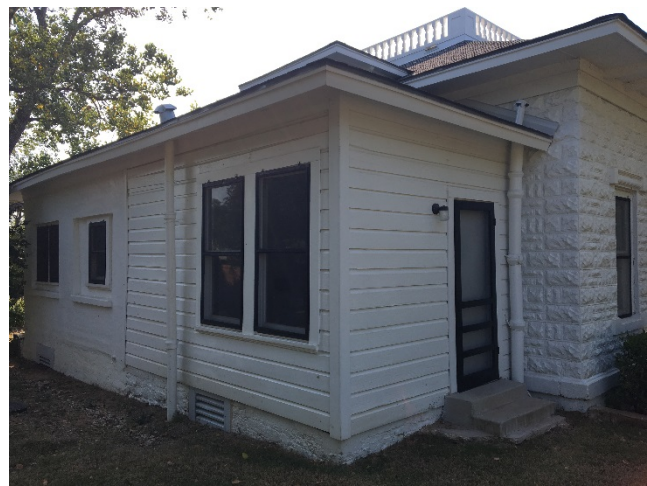
*The existing structure includes a single-story addition on the north. The addition is not constructed of the cast concrete block.*

- The existing house's exterior is in good shape and has been recently painted. The exterior shall be power washed with any peeling paint removed and those areas repainted.
- The existing house includes an addition of unknown age. The addition has foundation issues and the north side of the addition is sinking. If the addition remains, the foundation will need to be repaired with concrete piers.
- The addition can be removed pending approval by the Texas Historic Commission. The Texas Historic Commission was contacted regarding this option and was generally favorable of returning the home to its original configuration (circa 1911). Should the City choose to remove the addition, repair will be required to the existing north façade to restore it back to its original condition. This will include masonry repair and installation of period appropriate windows and doors.

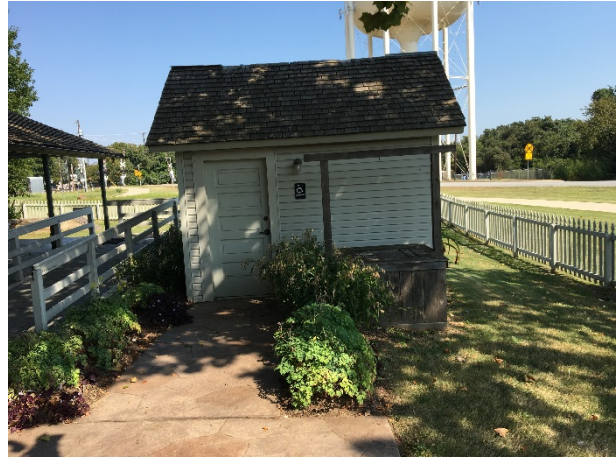
*Existing ramp and restroom*

- The outbuilding is a single story (120 s.f.) detached restroom.
  - o The outbuilding is generally in good shape.
  - o The restroom is located at grade, which is below the finish floor of the existing home structure. To access the restroom the public is required to exist the structure and navigate on the site uncovered. For many public occupancies uses, this path of travel to a restroom would violate code requirements.

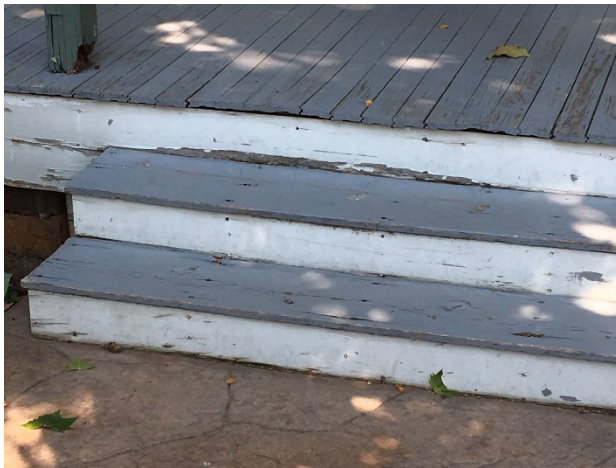
*Existing porch and steps (repair required)*

- The existing porch flooring and steps are buckling and should be replaced.
- Additional site lighting should be installed. The configuration will be dependent upon the use of the building, however, for this report it is assumed a variety of light fixtures, ground mounted and pole lighting will be added to illuminate the path of travel and existing structure at night.

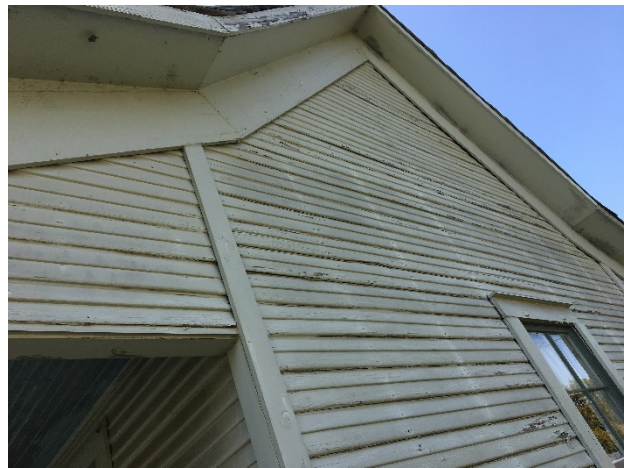
*Existing siding and trim (repair required)*

- The exterior of the two-story structure needs repair. The existing wood columns along the porch are showing signs of rot and should be replaced. The existing wood siding has paint peeling, exposing the raw wood to excessive weathering. All rotted wood siding and trim shall be replaced and painted.

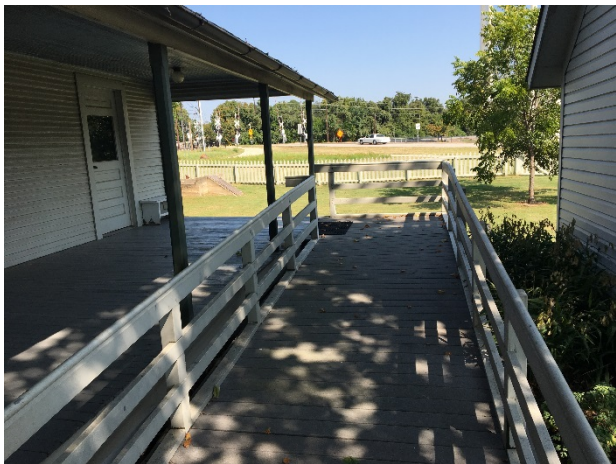
*Existing ramp (violates current ADA standards for slope, railing, and landing size)*

- A concrete ADA accessible ramp shall be constructed. The ramp shall include new railing and landing areas which meet accessibility standards.
- The existing mature trees adjacent to the two-story structure shall be trimmed/eliminated. The existing vegetation impedes the visibility of the structure from the street, parking and adjacent trail.
- The existing mechanical unit, adjacent to the north façade is visible from the trail and should be screened with vegetation.
- New vegetation and irrigation is recommended at the perimeter of the existing building.
- Should the existing structure be modified for use as restrooms for Cotton Belt Trail users, the existing unisex toilet (detached) should be removed complete.

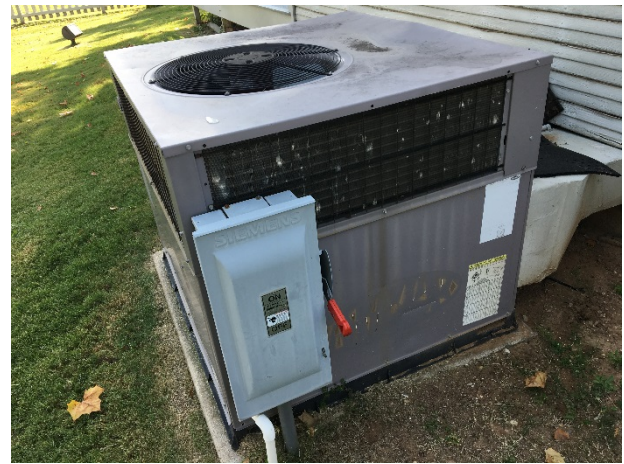
- o The HVAC is a modified roof top unit, located at grade adjacent to the north façade of the home. The system is nearing its lifespan. Modification to the interior of the structure will necessitate replacement. Should this unit remain, having is services and screening it is recommended, as it is visible from the Cotton Belt Trail access path.
- o The home includes water and sewer service. The plumbing layout will need to be revised to meet accessibility standards and improve the flexibility of the overall layout.
- o The electrical service was modified in 2002 with a 200-amp panel and copper wiring distribution to all outlets and light fixtures. The existing light fixtures are period appropriate, however, are not efficient. The original light switches (push button) have been utilized. Should the type of occupancy change, new light fixtures and switching will be required.

*Existing HVAC unit adjacent to north façade.*

- Should the interior layout of the existing structure be modified the existing HVAC system will need to be modified to accommodate the revised layout and functions.
- Should the interior layout of the existing structure remain, the existing HVAC system should be serviced to ensure proper function.
- The electrical system is in good condition. Based on the preferred interior layout, the existing distribution (outlets and lighting) will need to be modified accordingly.
- The existing plumbing will need to be modified based on the preferred interior layout.
