# City of Colleyville

# City of Colleyville Historical Preservation Committee Agenda Briefing

Discussion of the future use of Bidault House and Webb House

# **Bidault House & Webb House Property Assessment**

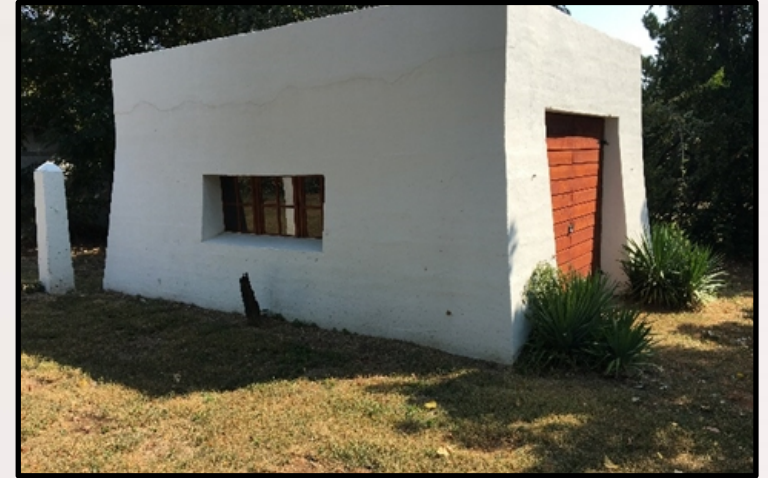
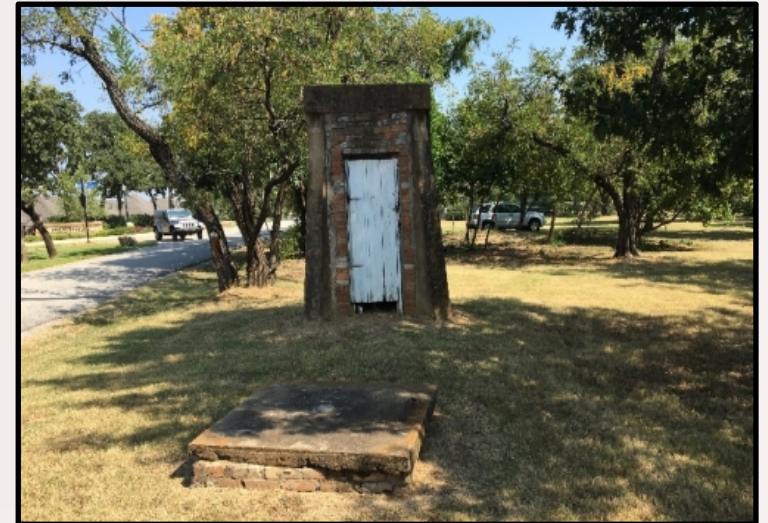
- Water & sewer service present – plumbing will need to be revised to meet accessibility standards and improve flexibility of interior layout
- Electrical service has modern circuit panel with copper wiring distribution to outlets and light fixtures, but does not meet code requirements
- Detached garage generally in good shape
- Site includes an existing well with pump-house

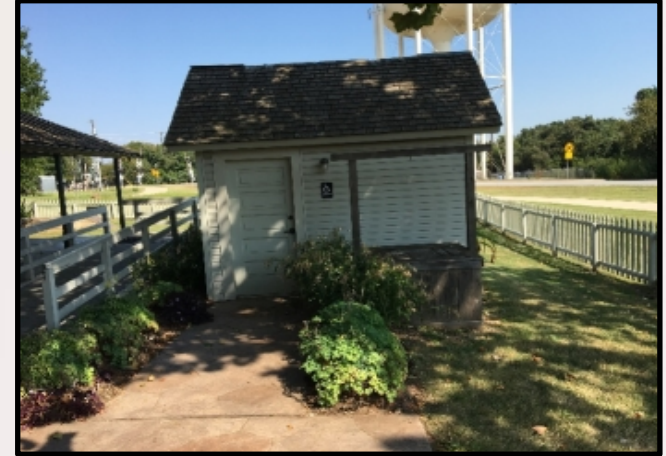
- 12 off-street parking spaces (1 handicap)
- Interior finishes generally in good condition
- HVAC is close to its lifespan
- New electrical service in 2002 renovation
- Exterior consists of wood siding and a wood shingle roof- both require repair/replacement
- Site includes single-story detached accessible restroom (2002)
  - The restroom is located at grade, below the finished floor of the existing home structure. To use the restroom, the public is required to exit the structure, and walk, without benefit of a cover (canopy, roof) to the restroom. For many public occupancy uses, this path of travel to a restroom violates code requirements.

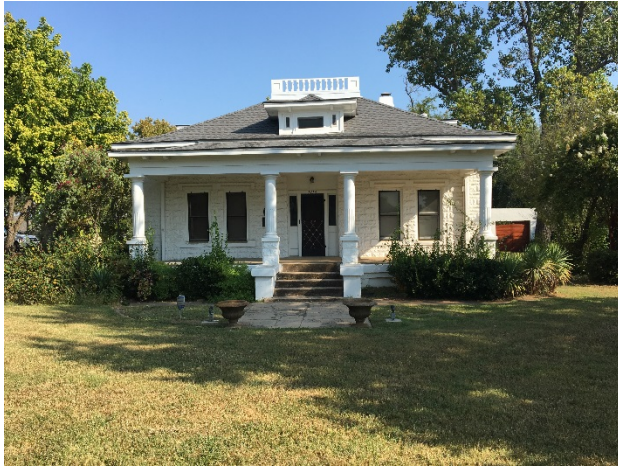
*Front Façade of Bidault House*

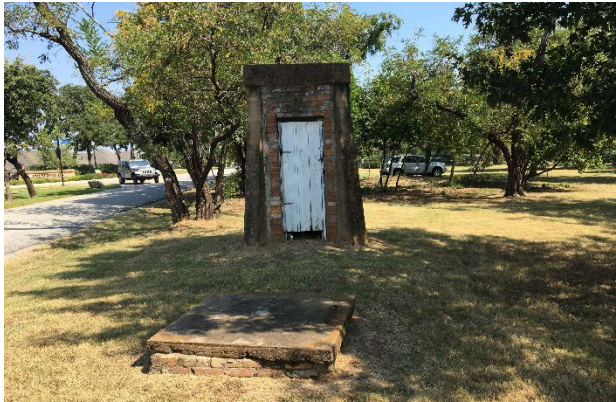
- The outbuilding is a single story (357 s.f.) detached garage.
  - o The outbuilding is generally in good shape.
  - o The exterior appears to be recently painted and new doors have been fabricated and installed. No modifications or repair are need for this structure, assuming it will remain as a storage facility.
  - o The site includes an existing well with pumphouse. The age of the well and pumphouse are unknown. The well is in the southwest quadrant of the property adjacent to the Bluebonnet Drive.

*Existing well and pump house*

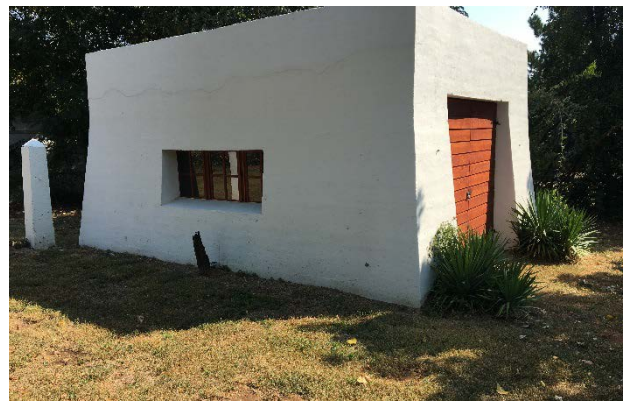
*Existing outbuilding (Garage)*

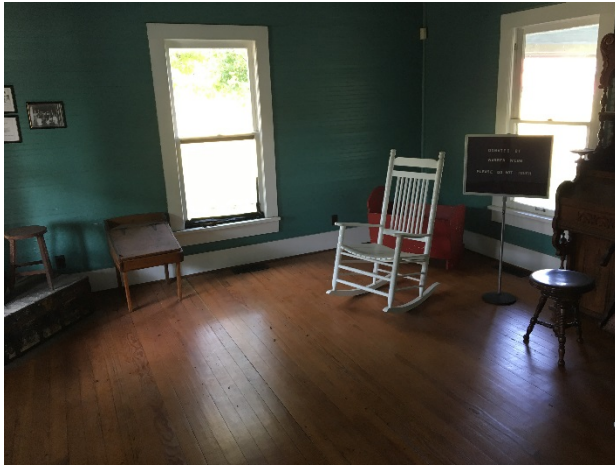
*Webb House interior*

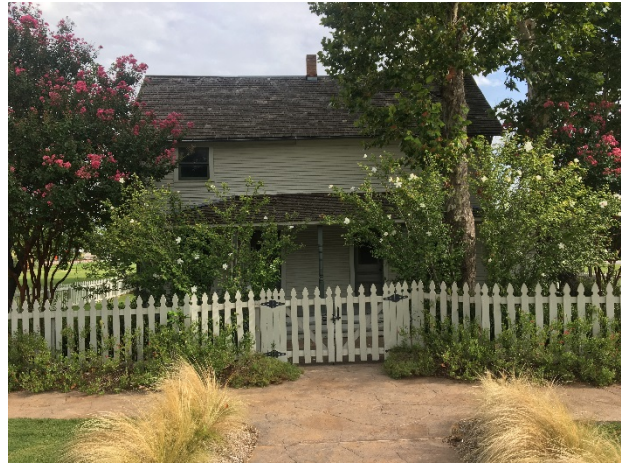
*Webb House exterior entry*

- o The exterior consists of wood siding and a wood shingle roof. Both the siding and roof are showing signs of weathering and will require repair/replacement.

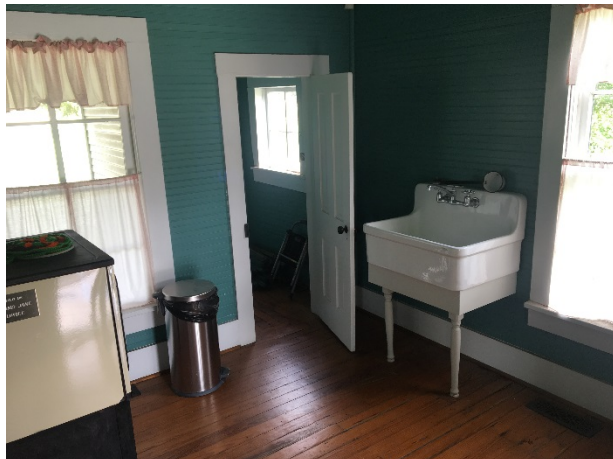
*Existing kitchen configuration*

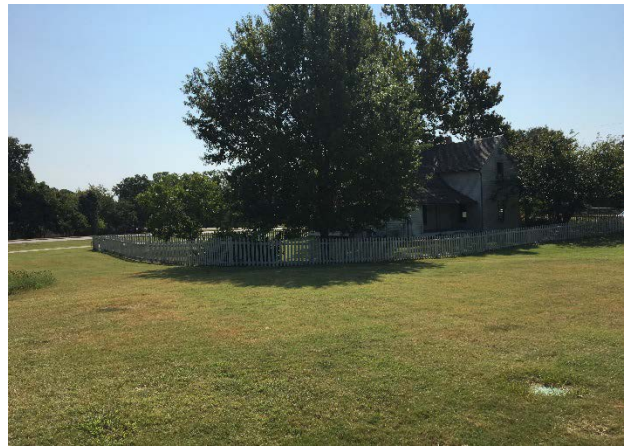
- o The HVAC is a modified roof top unit, located at grade adjacent to the north façade of the home. The system is nearing its lifespan. Modification to the interior of the structure will necessitate replacement. Should this unit remain, having is services and screening it is recommended, as it is visible from the Cotton Belt Trail access path.
- o The home includes water and sewer service. The plumbing layout will need to be revised to meet accessibility standards and improve the flexibility of the overall layout.
- o The electrical service was modified in 2002 with a 200-amp panel and copper wiring distribution to all outlets and light fixtures. The existing light fixtures are period appropriate, however, are not efficient. The original light switches (push button) have been utilized. Should the type of occupancy change, new light fixtures and switching will be required.

*North and west facades*
